MONITORING MEASURES OF SOME NATURAL ENGINEERING WORKS ON THE CHIASCIO RIVER, ITALY

Abstract

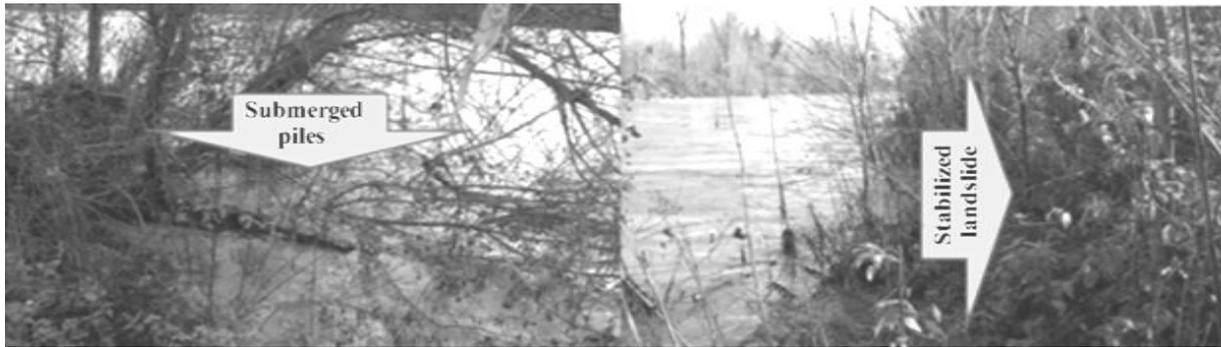
Fig. 2 - The impact of the quick flood of January 2016 on the bankside guard (A) and on the arrangement of unstable bank tract (B).

In particular, the event of 2016, by far the less intense, was monitored to assess the impact on the works, showing for the first intervention the complete submersion, while for the second intervention highlighting a partial involvement of the work, which, however, allowed to estimate a significant impact produced by the floods of 2010-2012 and 2013 (Fig. 2)

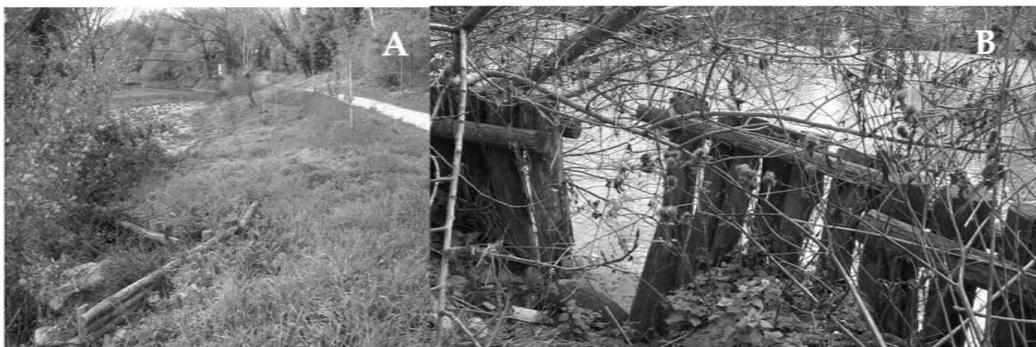
The application to the two works described previously took place at a distance of about 5 years after completion of the work. In this time period, the works were not receiving maintenance and significant events have occurred. The results are summarized in the summary card of Fig. 7. One can observe how the first intervention of riverbanks protection has presented a good behaviour during this first period of life (Fig. 7A and Fig. 8A) with the only problem related to a failure localized on the piling. In fact, in correspondence with the curved portion of the upper crossing they were interrupted without any discontinuities. Consequently, the piling woods was disconnected from the rest of the structure and was not supported by any tie-rod (Fig. 8B).

Fig. 8 - View of the arranged side (A), and the disconnected piling woods(B)

Such an error in the execution phase was highlighted during the floods that have submerged completely the work, particularly during the withdrawal of the waters; the structure was biased towards the river, resulting in forward sagging and erosion of land behind. In the case of the second intervention, the card shows more critical problems (Fig. 7B), In fact, the case presented localized problems and issues regarding the materials, which determined an insufficient judging of the behaviours, that adversely affected the overall

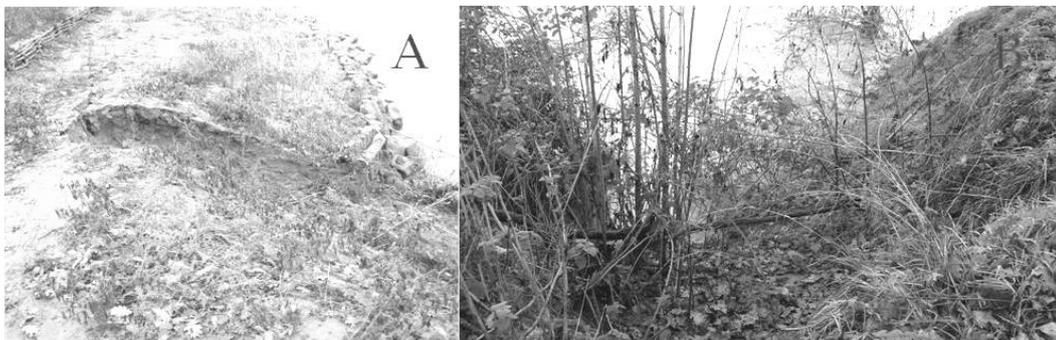
behaviour of the work. The located problem was highlighted since the first flood event and was linked to an incorrect initial connection between the work and the bank (fig. 9A), which led to a marked localized erosion area by the failure of a stump that perhaps it had been attributed excessive consolidation function. Over the years, the regrowth of shrub vegetation has partly concealed the problem, which, however, remains even if it did not show a particularly rapid extension of the eroded area (Fig. 9B).

Fig. 9 – View of the erosion zone at the beginning of the work, the situation shortly after the end of the work (A) and 5 years after (B)

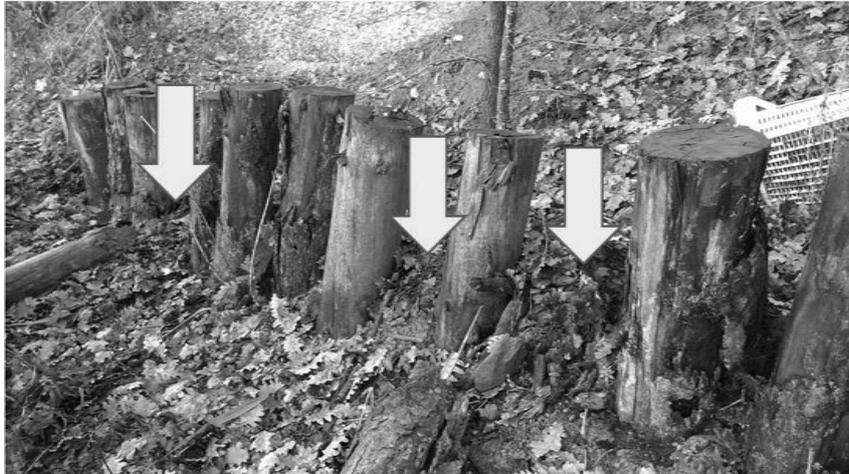
Fig. 10 - Detail of the completely deteriorated pine elements of the piling

The second problem was instead highlighted over the years and was linked to the type of used wood materials. In fact, it was found that not all piles were chestnut. In fact, some were pine and have undergone an evident degradation phenomenon in the aboveground part, until they completely decayed (Fig. 10). This situation needs to be verified in the stuck part that is less subjected to repeated wetting and drying phenomena. However, it indicates that the choice of the wood material has to be examined carefully in the individual elements of the structure.
