MONITORING MEASURES OF SOME NATURAL ENGINEERING WORKS ON THE CHIASCIO RIVER, ITALY

Abstract

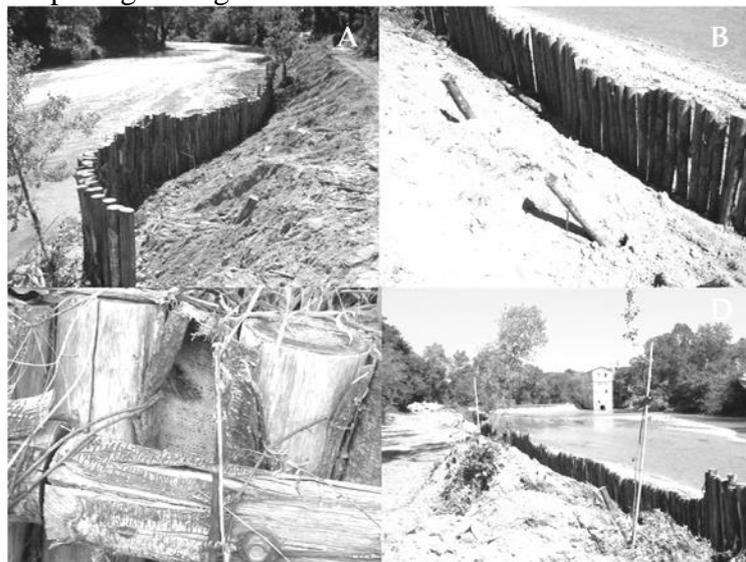
Fig. 3 - View of the development line of the piling (A), particularly of the anchor rod (B), the transverse alignment of the front (C), planting of vegetation in the banks (D).

To provide continuity to the structure, the inclined poles were placed and clamped at the rear of the riverside (Fig. 3B) representing the anchors for the steel rods. Rods were connected with two cross poles placed on the top of the piling edge (Fig. 3C).

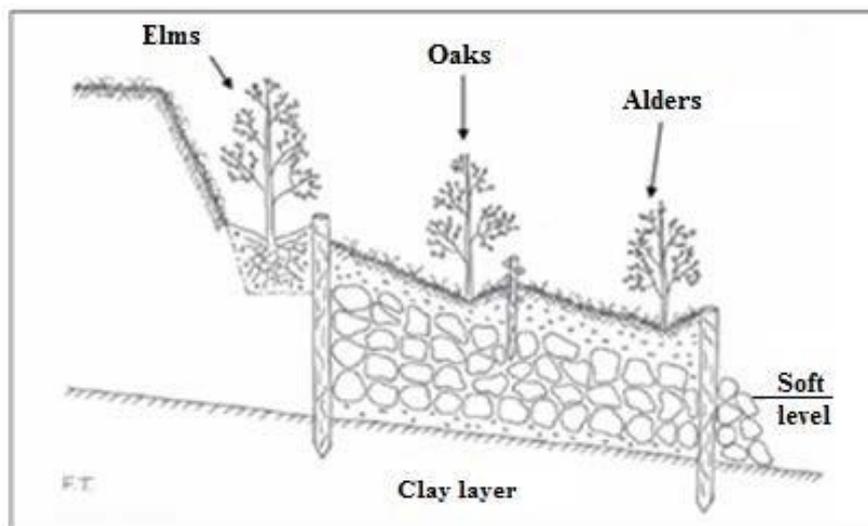
Fig. 4 - Operation scheme of the landslide stabilization in the central section and the corresponding drainage (Torti, 2012)

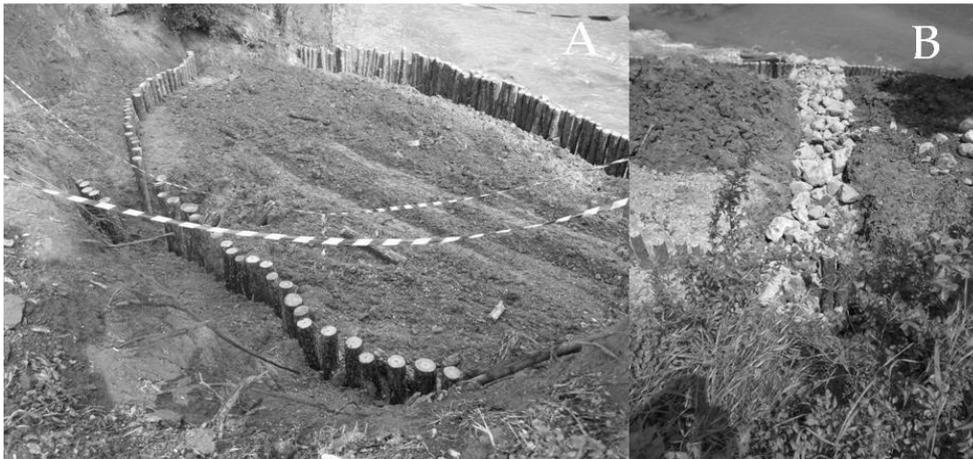
Therefore, the chestnut poles with a diameter of 20 cm were arranged in two rows (Fig. 5A) and fixtures for a length of approximately 4 m, to affect the sliding surface of the body in landslide, represented by the layer of clays, interposing in this way the phenomenon dynamics. In the central area of the landslide, the body of a deep drainage was also carried out for controlling the disposal of water infiltration that could be possibly present in the soil (Fig. 5B). Thus, the surface area is searched to better control the action of surface waters, both from raining or water withdrawal after flood events. In particular, the latter were arranged in three levels, with the use of usual species of native types: in the first level (the one closer to the water, upstream of the first piles) were planted alders; in the second level (upstream of terrace oaks have been placed and finally, in the third level (upstream of the second row of poles) elms were placed, which were resistant to graphiosis - *Ceratocystis ulmi* (Fig. 6). This provision follows the positioning generally observed on the typical rivers in the area, bearing in mind that the alder is placed at the foot of the arrangement. Due to the features of its root system, once developed, alder provides more stability.

Fig. 5 - Realization of two rows of wooden poles (A) and of the central drainage (B)

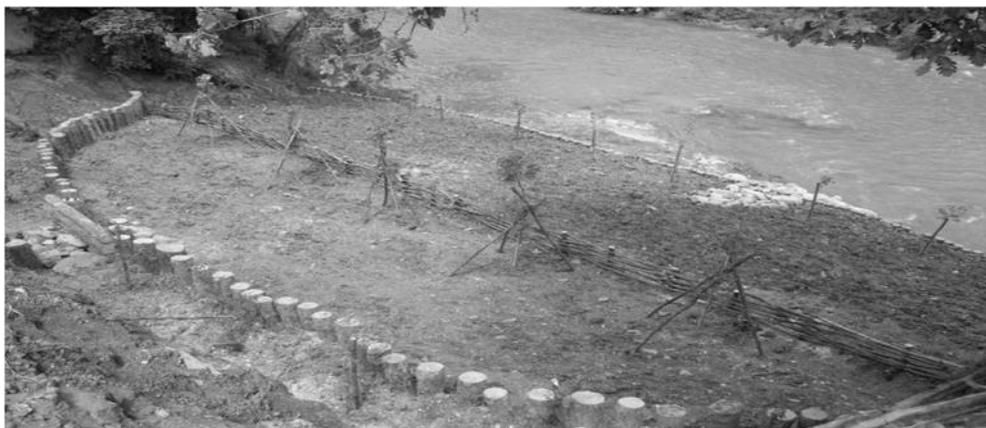
Fig. 6 - View of surface arrangements
